# Manhole Inspection Summary

Manhole # S31UU\_018MH

**Location** Address: **3037 REMINGTON AVE**

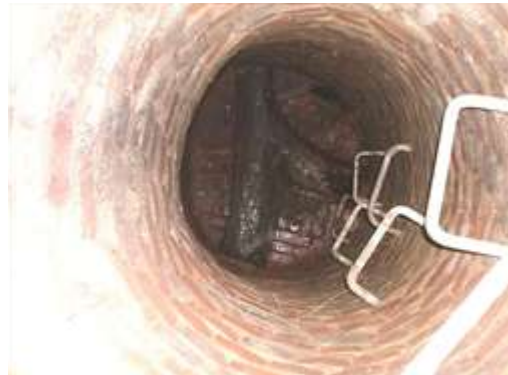
Top View

Corbel root intrusion. Corroded steps.  
Bench and Channel debris.

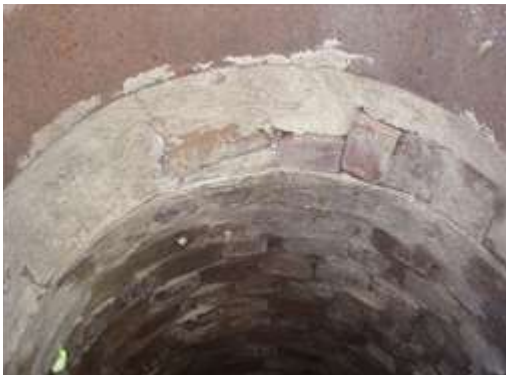
Defect

Frame leaks. Adjustment deterioration  
and infiltration. Corbel infiltration.

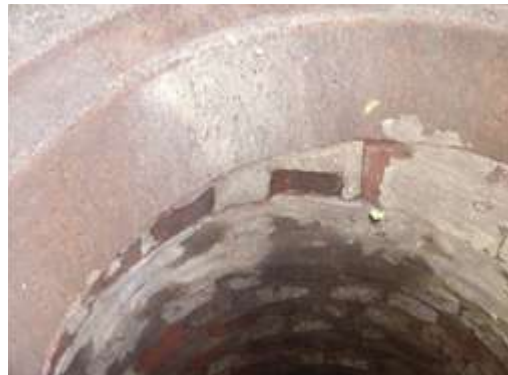
Defect

Frame leaks. Adjustment and Corbel  
infiltration.

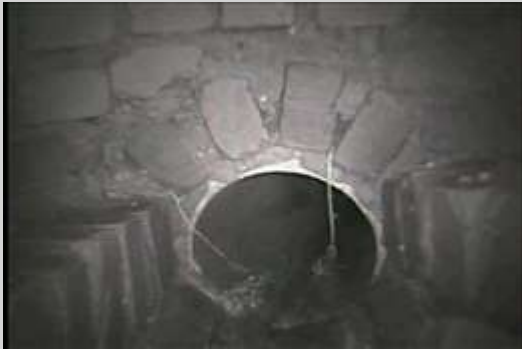
### 8 in. Circular Gravity Sewer Pipe Out @ 12 O'Clock

Infiltration: **None** Pipe Seal Cond: **Broken**

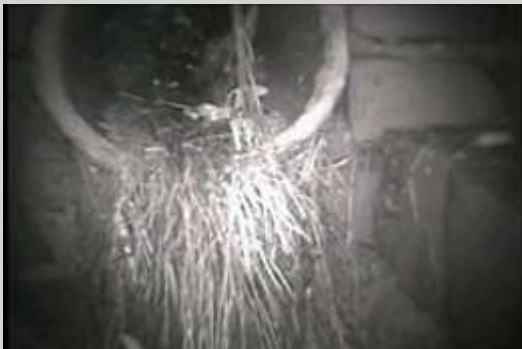
### 6 in. Circular Gravity Sewer Pipe In @ 3 O'Clock

Channel root intrusion.

Infiltration: **None** Pipe Seal Cond: **Roots**

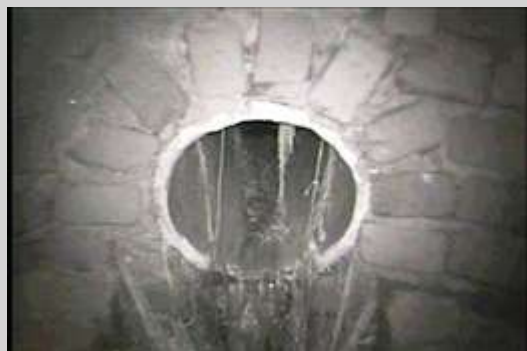
Barrel root intrusion and infiltration.

Pipe Seal Cond: **Roots**
